SKF Pulp & Paper Practices

SKF Global Pulp & Paper Segment / No. 22 / December 2017

My fan is running hot!

Mounting CARB on a fan without a hydraulic nut

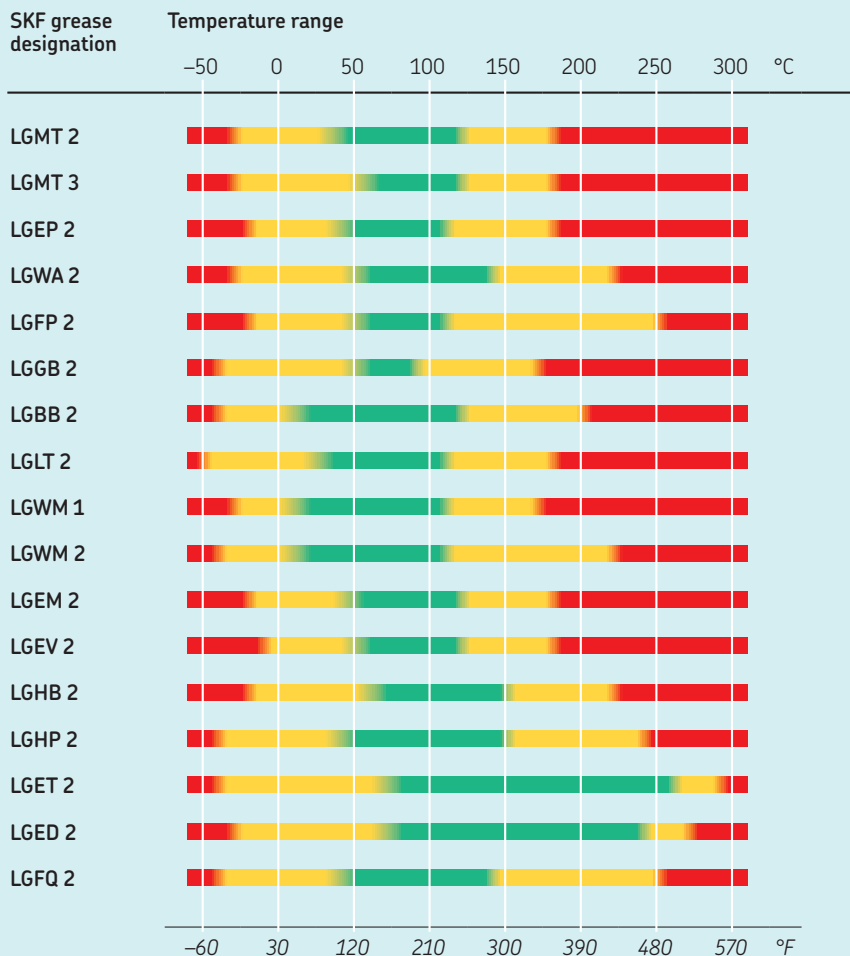
Table 2

Wide high temperature diagram
